SRE FUEL ELEMENT DAMAGE

FINAL REPORT

SRE FUEL ELEMENT DAMAGE
FINAL REPORT

CONTRACT: AT(11-1)-GEN-8
ISSUED: JUN 30 1961

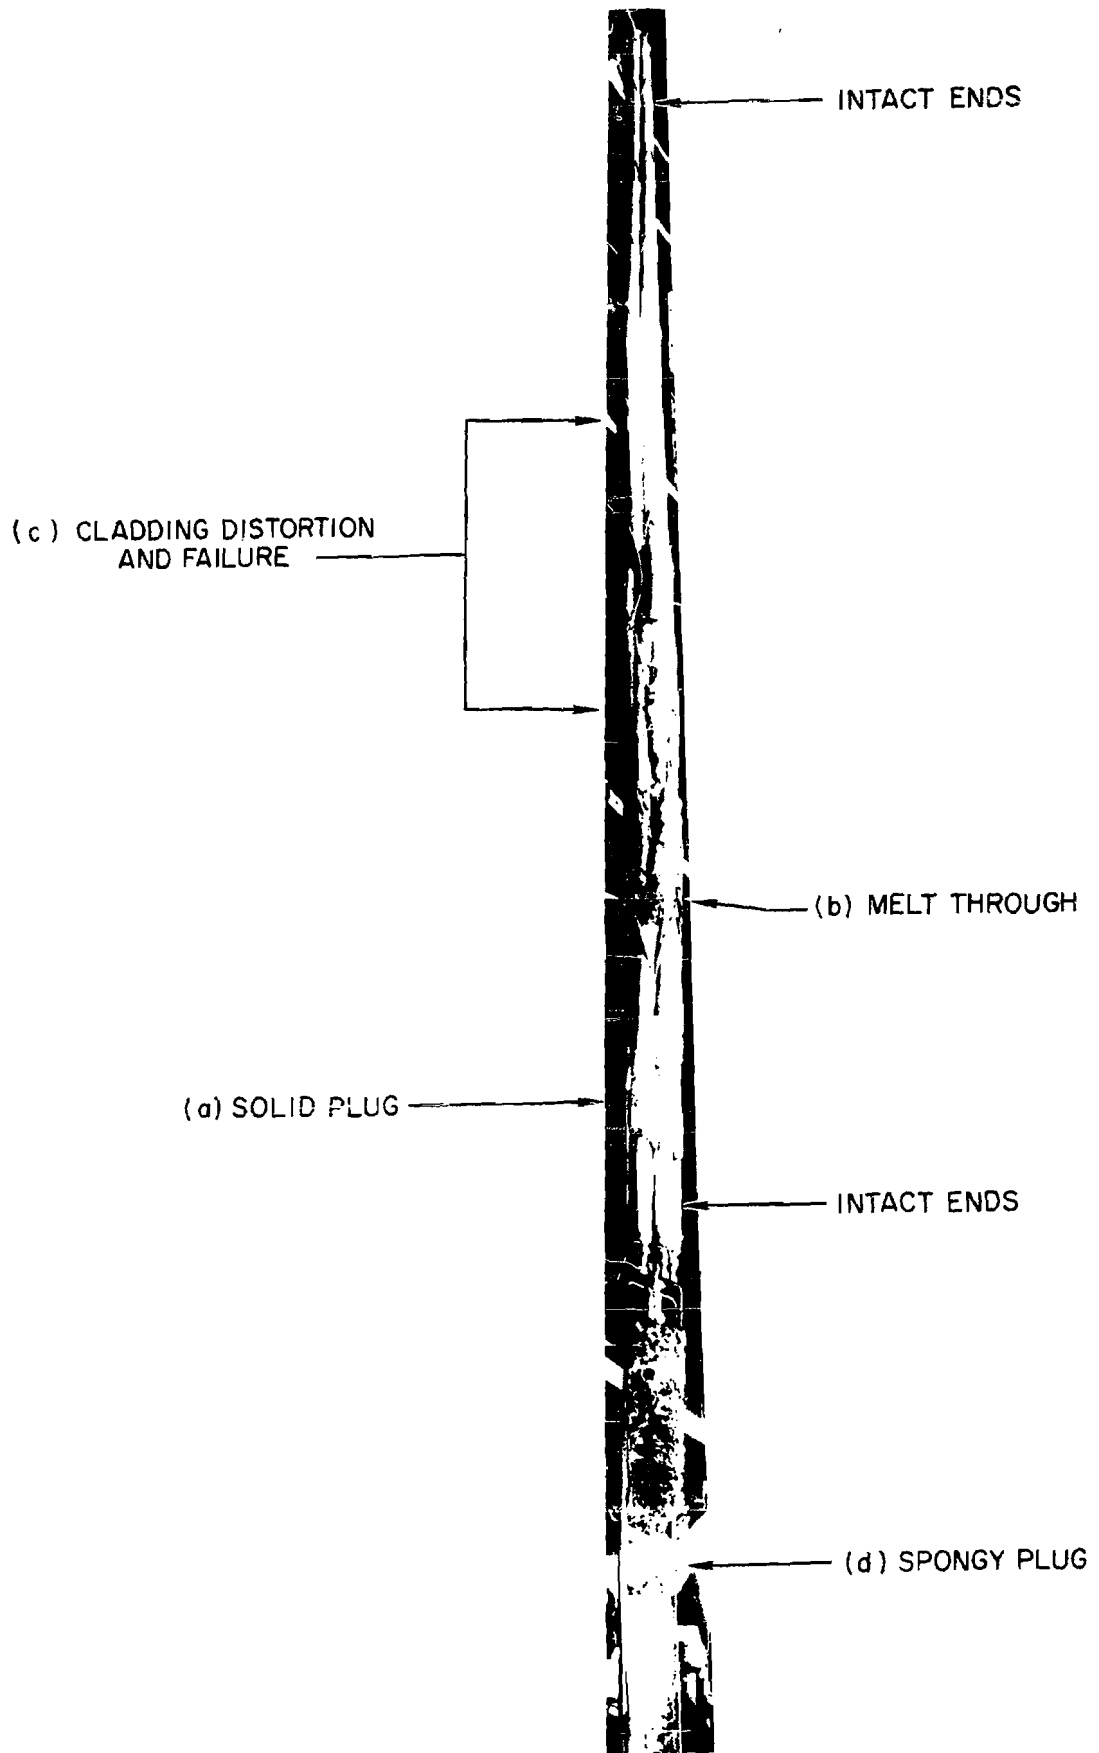
Figure III-1. Fuel Element From Channel R-24

The results are shown in Figure III-1. Several features should be noted: (a) the solid plug of material about 1-ft above the bottom of the fuel rods, (b) the Fe-U alloy melt-through area about one-third of the way up the element and extending for several inches, (c) the region above the melt-through where the cladding had been distended until it burst, and (d) the black spongy plug in the channel below the element.

The solid plug was determined metallographically to consist of Fe-U alloy of near-eutectic composition. Its source was the melt-through area above, from which Fe-U alloy, formed near the surface of the slugs, penetrated and destroyed the cladding.

The cladding breaks above the melt-through area were typical of a ductile material, and cladding pieces from this area were readily bent with the hot cell manipulators. There was no evidence of Fe-U diffusion in this area; the failure is attributed to swelling of the fuel from thermal cycling.

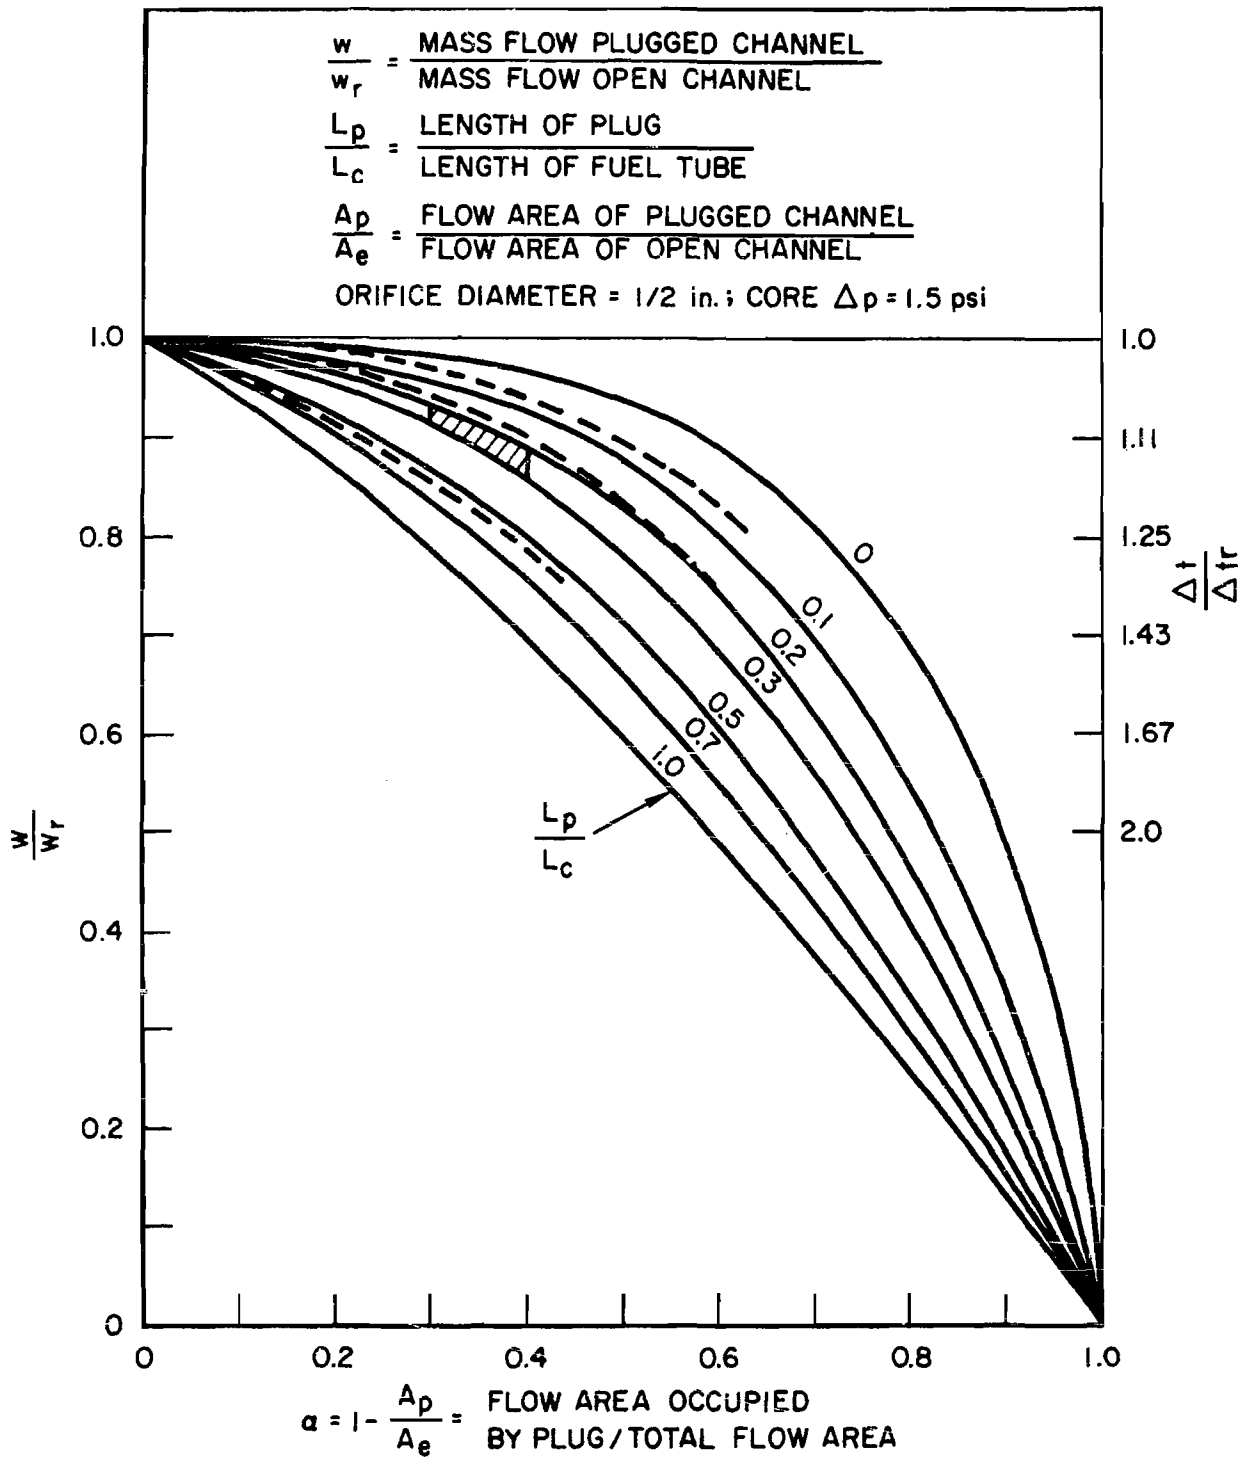
Figure III-4. Mass Flow Reduction in SRE Fuel Channel Due to Formation of Plugs in Fuel-Tube Region

The plugs must have been large in order to reduce flow in a given channel to one-third of nominal flow. The relationship of flow to plug geometry in a channel is indicated in Figure III-4. As shown in the figure, a very short plug (thin

plate) would have to occupy about 95% of the flow area around the fuel rods to reduce flow to one-third; if the plug were as long as the channel, it would have to occupy about 75% of the flow area to reduce flow to one-third. The calculations leading to Figure III-4 assumed no plug porosity. With some flow through the plug, the plug would have to occupy a still larger fraction of the channel to restrict flow a given amount. The few observations of the spongy plugging material, in channel R-24 and on top of the core, together with the data of Figure III-4, would indicate that the plugs were probably long (a few feet) and occupied most of the flow cross sectional area.

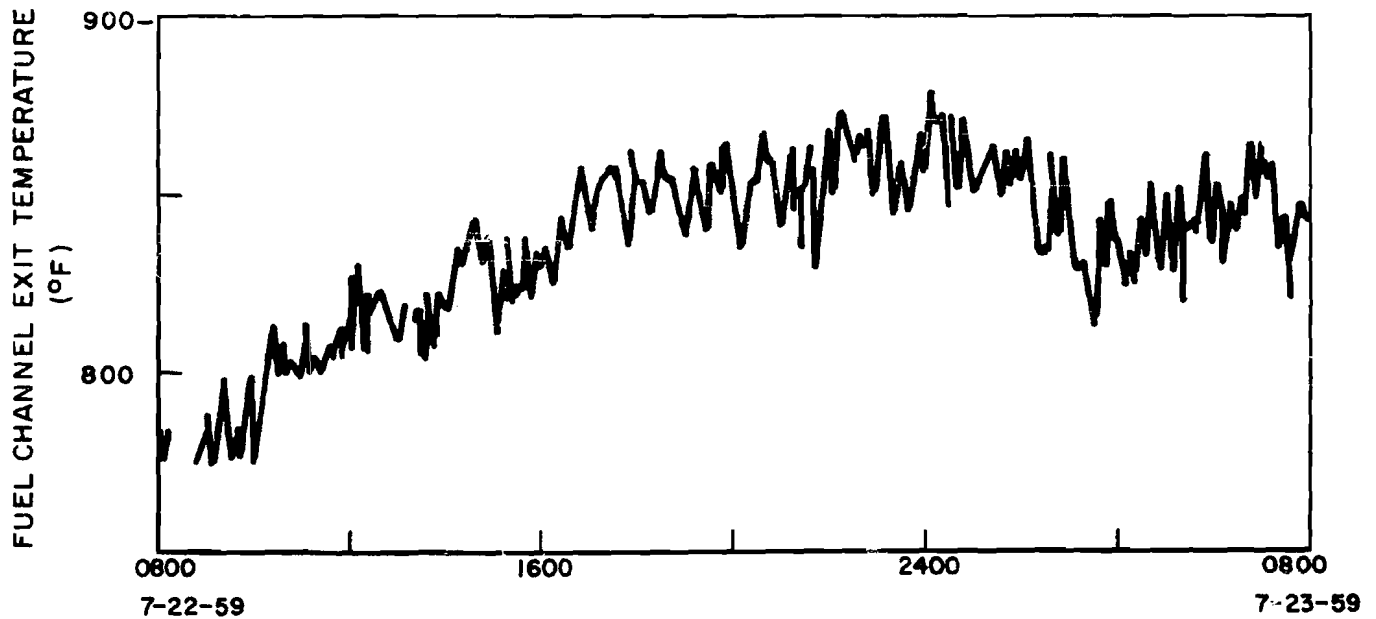
Figure III-7. Outlet Temperature for Channel R-55

shown in Figures III-7 and III-8. As indicated by the figures, the fuel temperature was cycling over a range of about 150°F while outlet channel temperature variation was about 50°F.
